Manhole Inspection Summary

Manhole # S23C1_023MH

Insp Date: **7/7/08 2:11 PM**

Location Address: **2401 Maisel Ct**

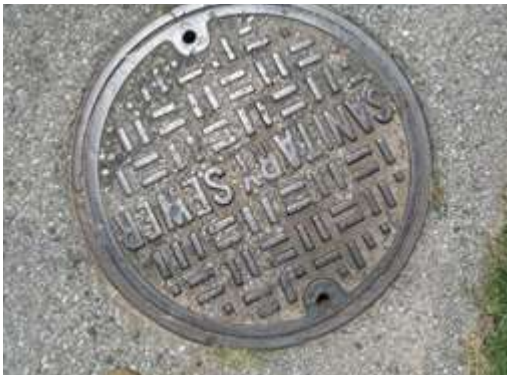
MH Cover

Condition: **Sound**

Cover Material: **Cast Iron**

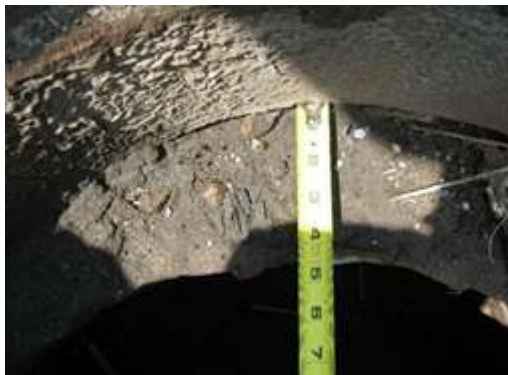
Defect 3

4.5" offset

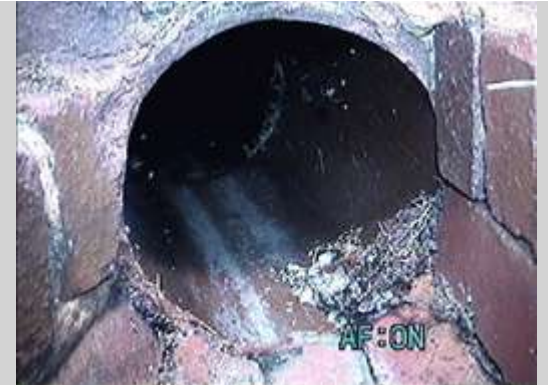
12 O'Clock Outflow

8 in. Circular Gravity Sewer
Pipe Out @ 12 O'Clock

Pipe Height: **8.4** (in.) Rod and Bar (Angled)
Pipe Material: **Clay** ☐ Pipe Lined
Invert Depth: **5.93** (ft.) Flow Characteristics: **Slow**
Deposits: ☒ None ☐ Mud ☐ Sludge ☐ Debris ☐ Grease
Silt Depth: **0** (in.) Deposits Extent:
Infiltration: **None** Pipe Seal Cond: **Roots**

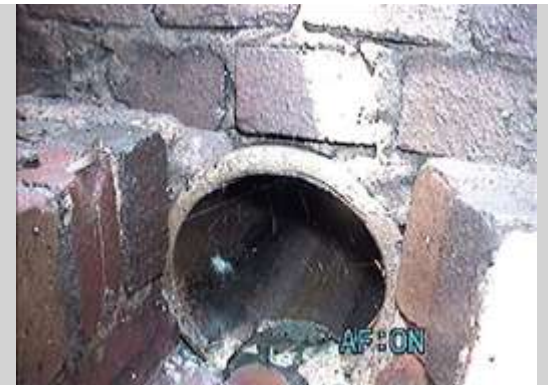
8 O'Clock Inflow

6 in. Circular Gravity Sewer
Pipe In @ 8 O'Clock

Pipe Height: **6** (in.) Rod and Bar (Angled)
Pipe Material: **Clay** ☐ Pipe Lined
Invert Depth: **5.75** (ft.) Flow Characteristics: **Slow**
Deposits: ☒ None ☐ Mud ☐ Sludge ☐ Debris ☐ Grease
Silt Depth: **0** (in.) Deposits Extent:
Infiltration: **None** Pipe Seal Cond: **Sound**
